A Tough Decision in Tough Times

Larry Goshorn

POES Program Issues in 2000

Fault Tree Analysis and Empirical Testing

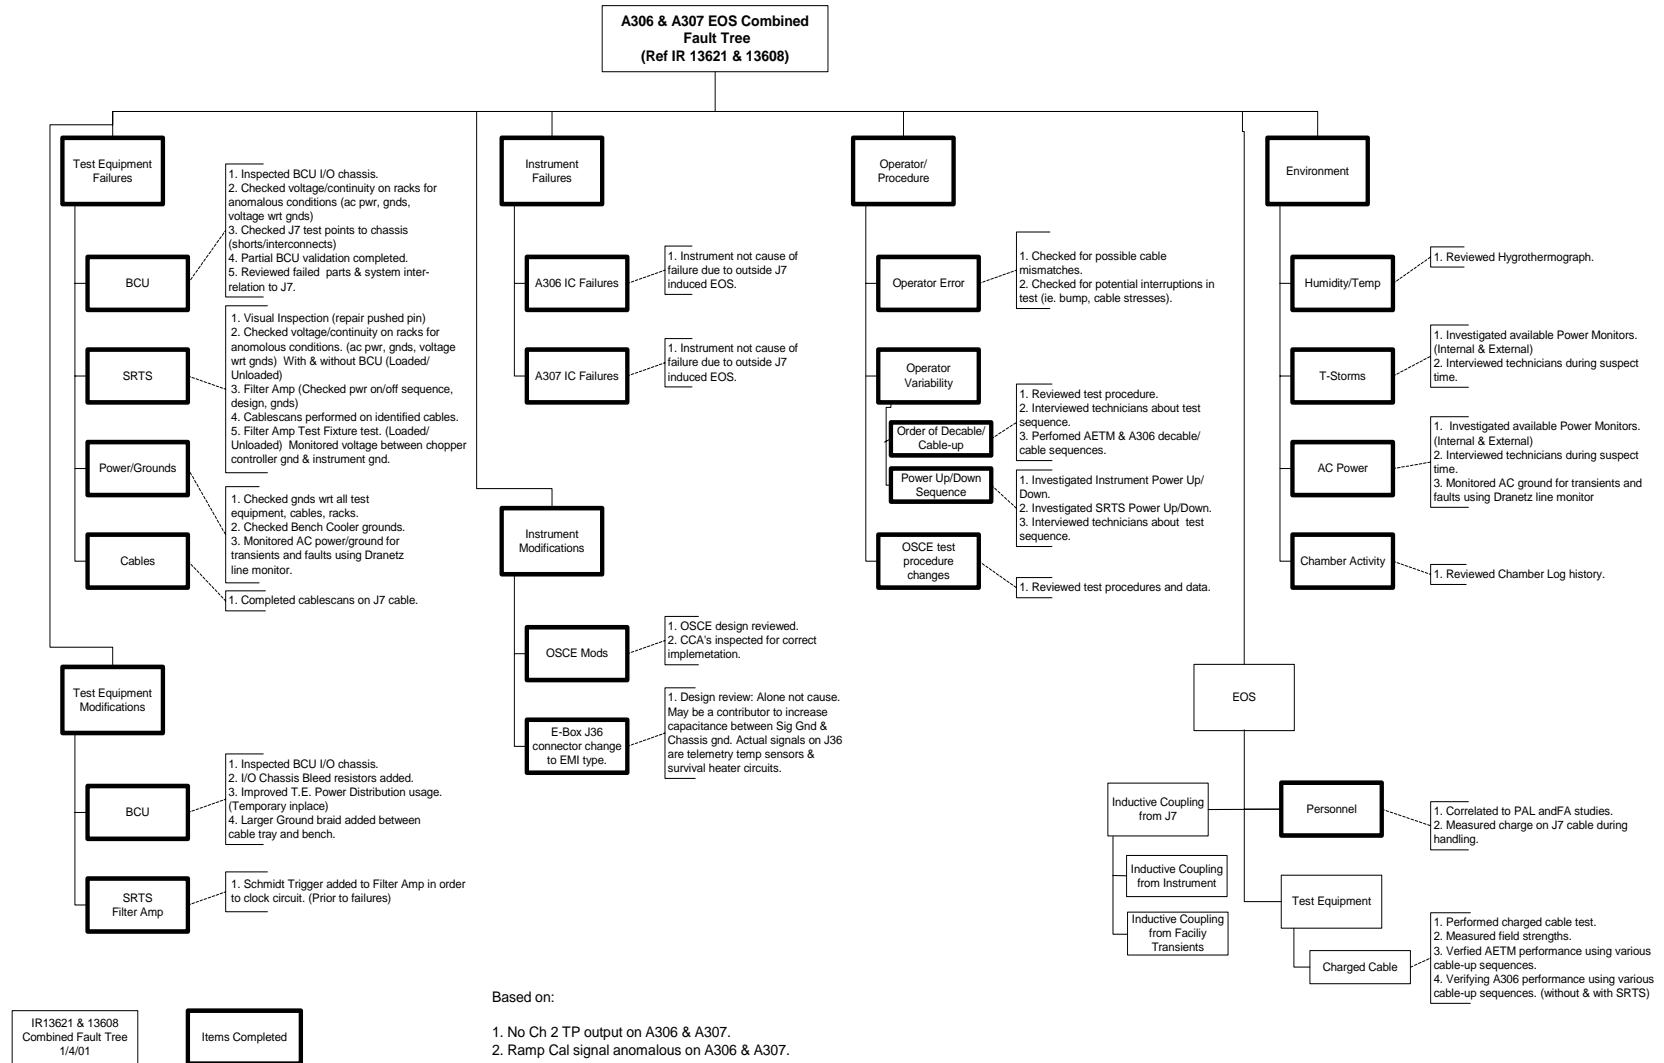
1. Facility grounding issues due to re-wiring of Labs (Transients)

2. Test Equipment Issues

- **Charge accumulation ($>200\text{v}$) on Long test cable which discharged into instrument during connector mate/de-mate**

3. Inductively coupled “cross talk” through test cables of transients or static discharges during cable mate/de-mate

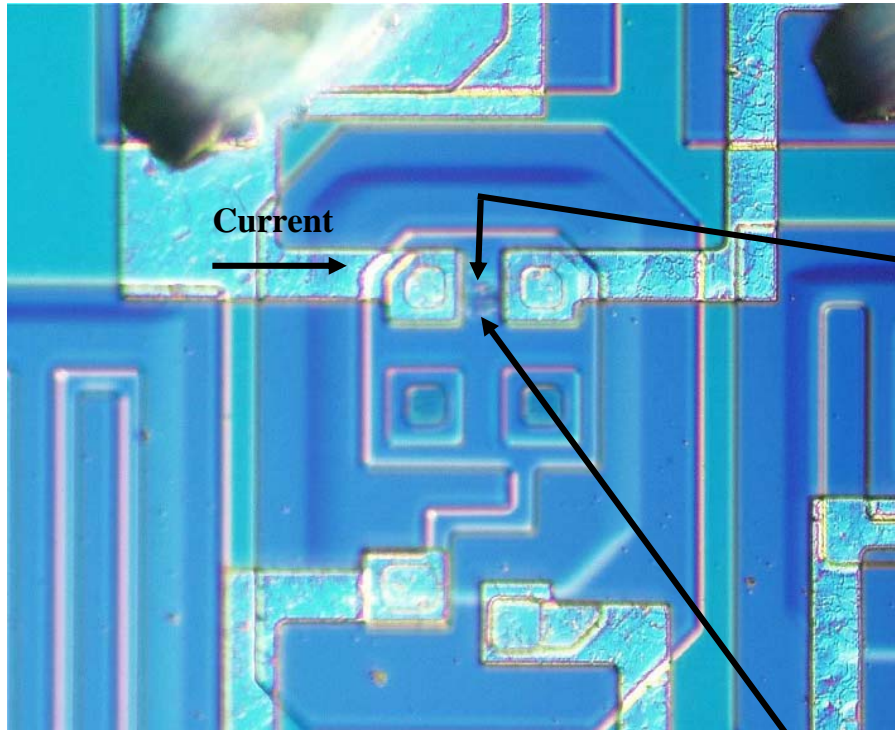
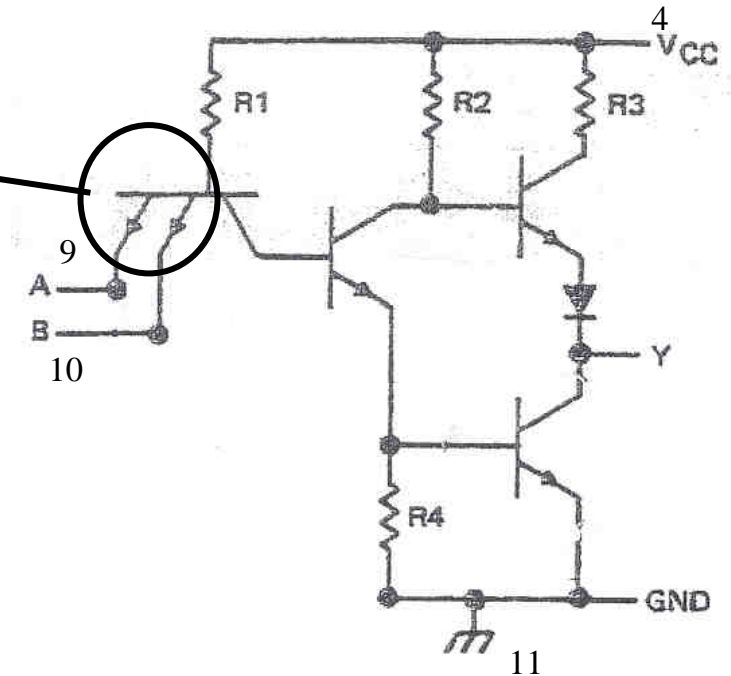
U14 NAND Gate Damage (A307)
(Location: Motor Logic CCA)

Direction of Current Flow Was Determined by Physical Inspection of Failed Parts

Aluminum that has flowed
across contacts

TTL input pins 9 and 10 are shorted together and to V+.

Destructive current entered pin 10 and exited pin 9 that was tied to ground externally.

Destructive overstress voltage

7 volts above ground (min)

100-1000 volts probable

Short duration EOS event

The short to V+ is secondary damage.

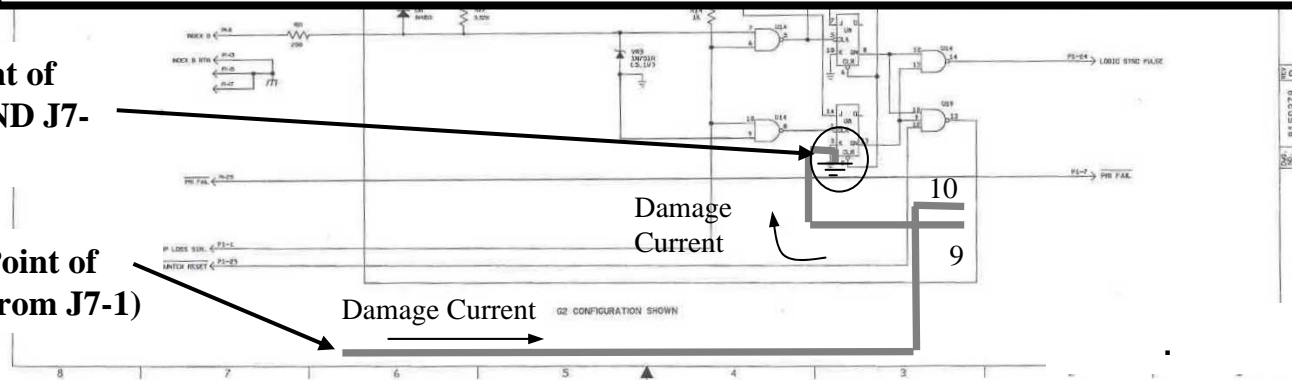
Evaluation of Circuit Schematics Confirmed J7 as the Source of the EOS

Exit Point of
EOS (GND J7-
16)

Entry Point of
EOS (From J7-1)

Current shunt circuits at J7	Provides protection for any high voltage inputs on J7 cable	TBD	AVHRR
Additional monitoring at J7	Capture any anomalous signals on the J7 test cable	ECD 1/15	AVHRR

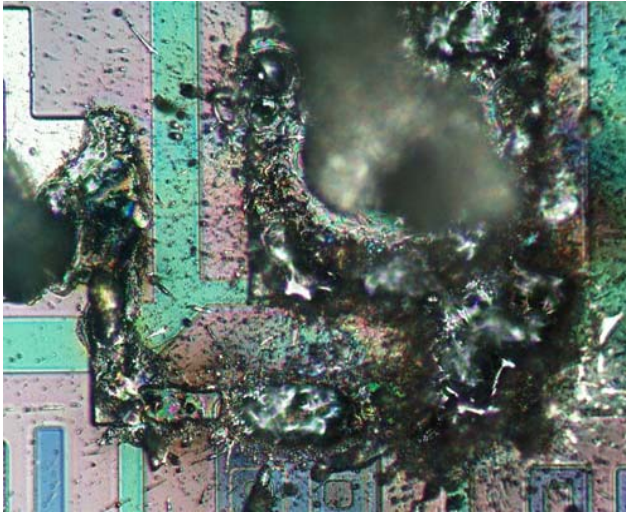
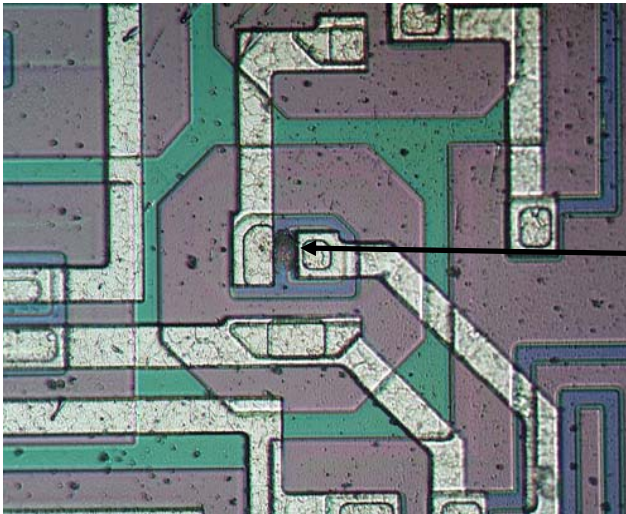
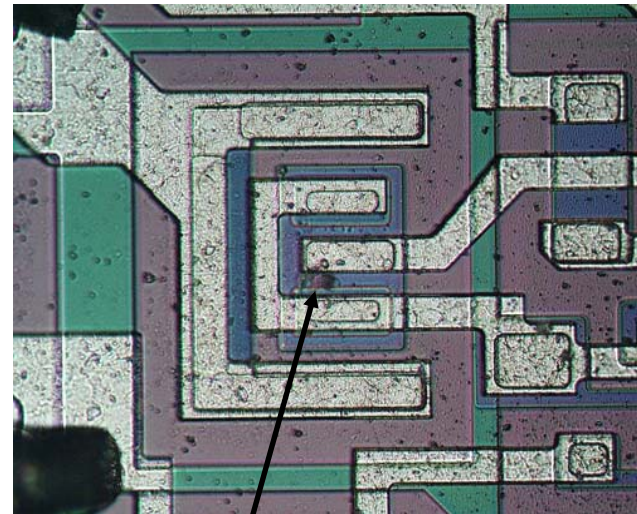
SEM Analysis of Damaged Parts

EOS
Initiated
.....Bulk of
Damage
Caused by
Power
Supply
Short

Damage to Other Gate Transistors
Provides a Shorting Path to Ground

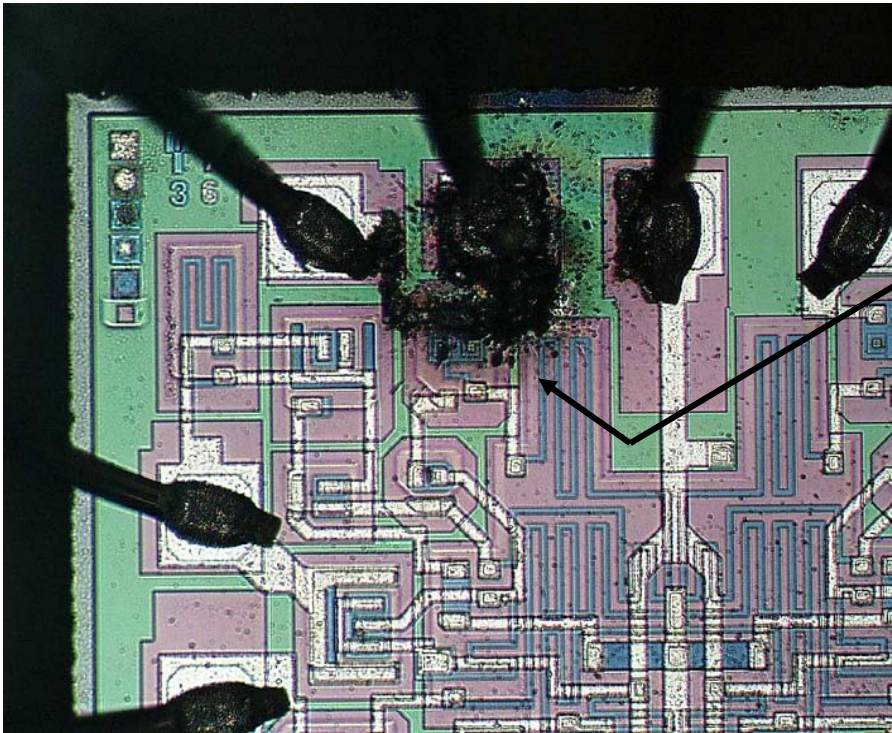
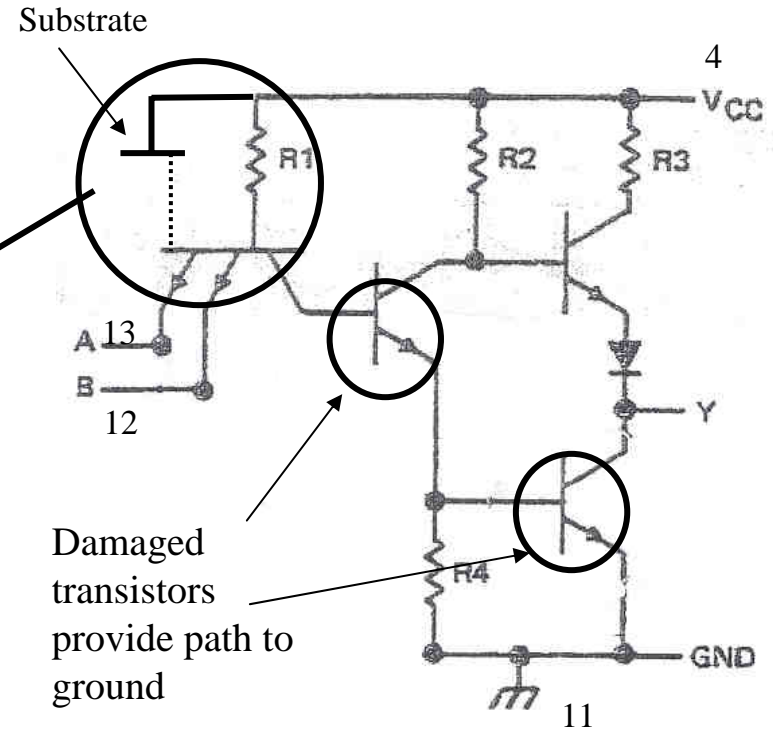
Gate Damage (A307)

EOS Induced Short to the Die Substrate Initiates More Extensive Damage After Power Up
