of a Mishap Investigation

BY RICK OBENSCHAIN

ANATOMY

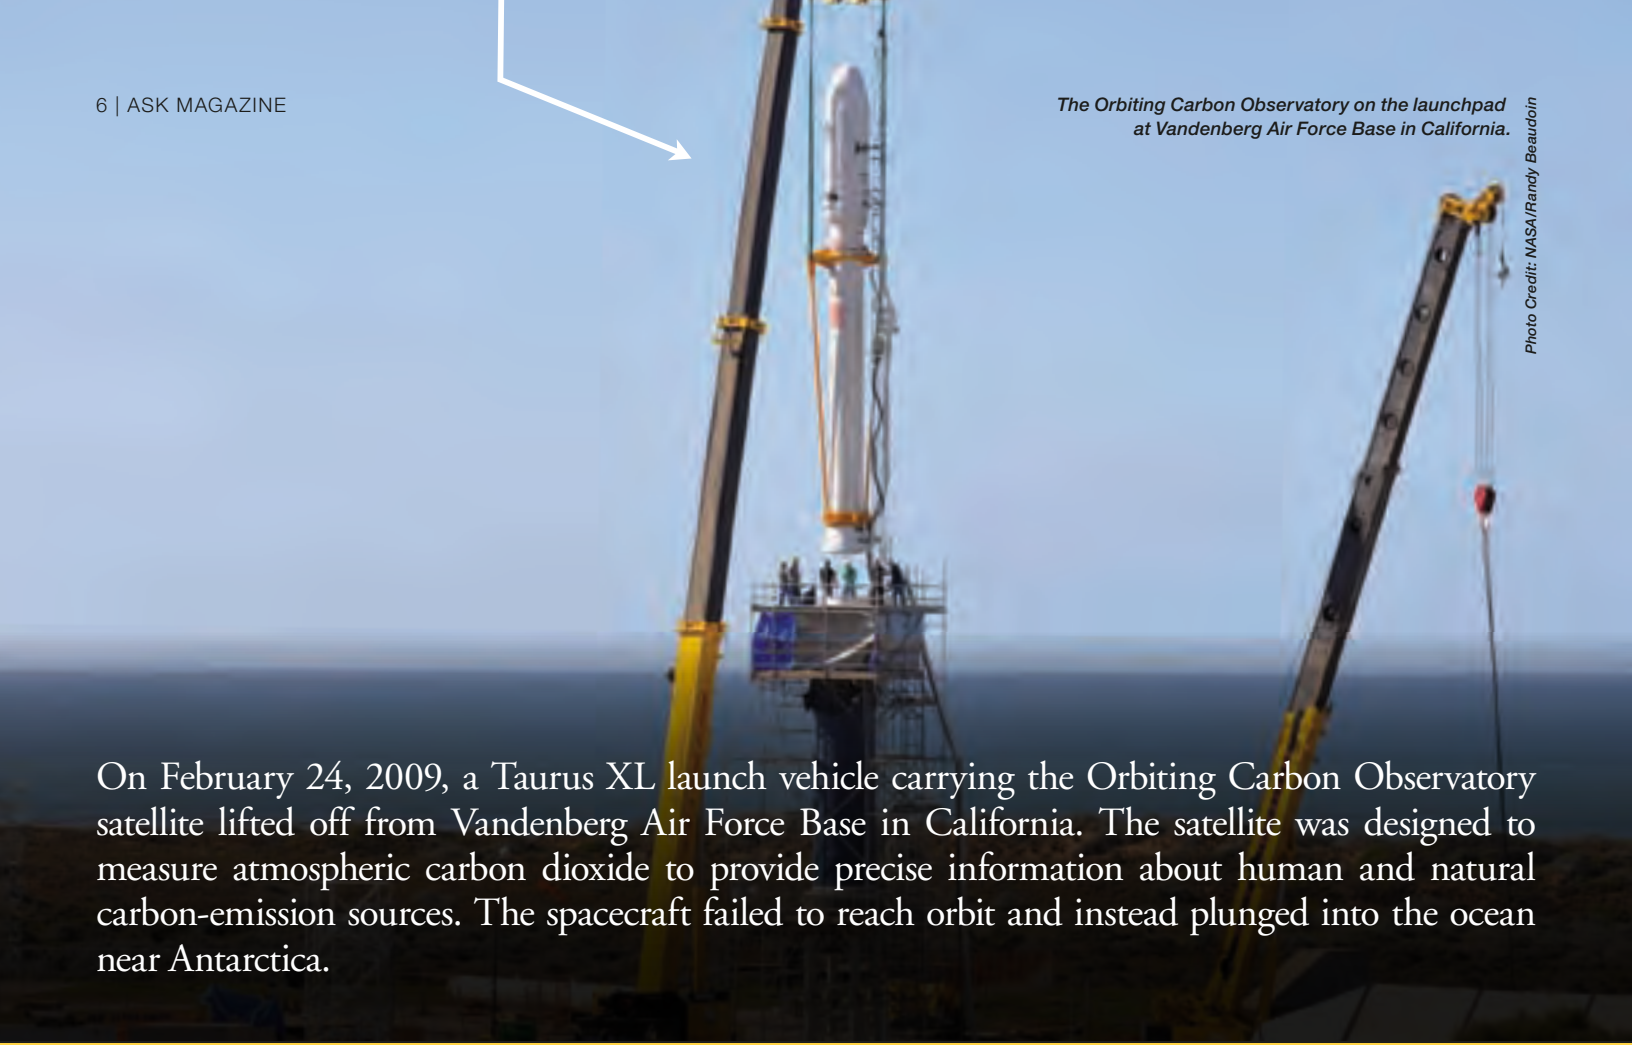
NASA's Orbiting Carbon Observatory and its Taurus booster lift off from Vandenberg Air Force Base. A contingency was declared a few minutes later.

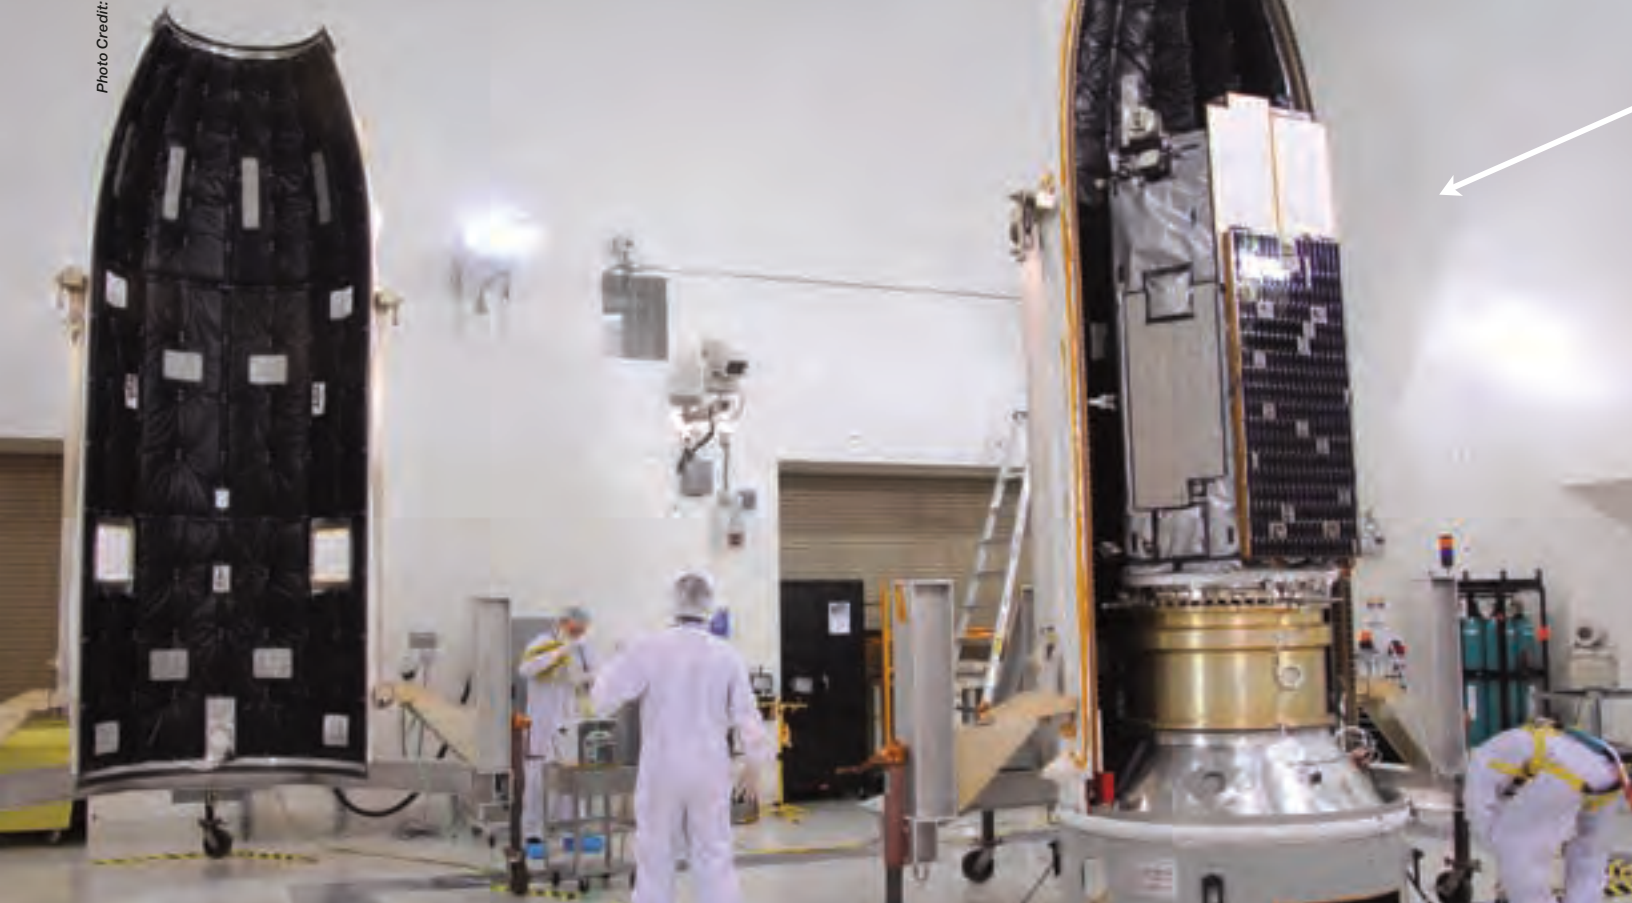
Photo Credit: NASA
 Inside Building 1032 at Vandenberg Air Force Base, technicians install the Orbiting Carbon Observatory spacecraft inside the payload fairing.
