National Aeronautics and Space Administration

## **Academy of Program/Project & Engineering Leadership**

### **Columbia's Last Mission**

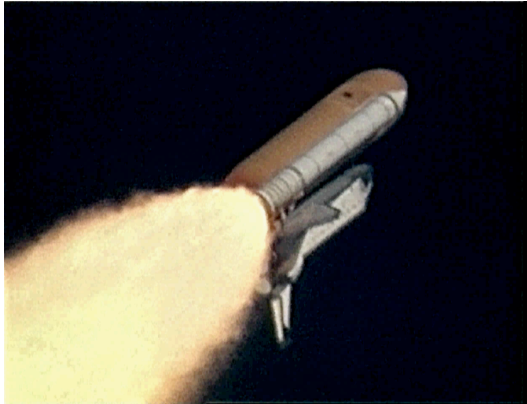
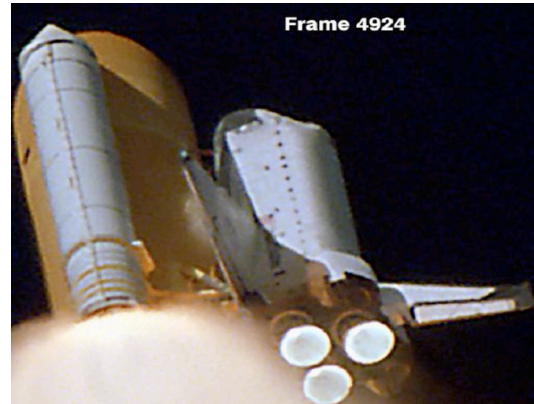
At 81.7 seconds after launch, a large piece of foam approximately 21 to 27 inches long and 12 to 18 inches wide and at least two smaller pieces separated from the [External Tank left bipod \(–Y\) ramp area](#). The larger piece, tumbling at least 18 times a second and moving at more than 400 miles per hour, relative to the Orbiter, struck *Columbia* on the underside of the left wing, around [Reinforced Carbon-Carbon \(RCC\)](#) panels 5 through 9.

*Figure 1.1.* Two ground camera views of the debris strike show a shower of foam after impact on Columbia's left wing. The event was not observed in real time.

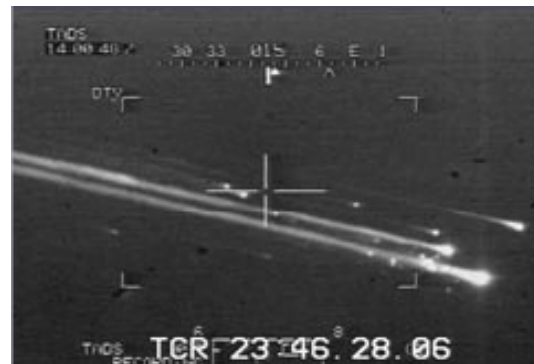
Figure 2.2. An infrared image taken by a military helicopter shows the breakup of Columbia.
