National Aeronautics and Space Administration

## **Academy of Program/Project & Engineering Leadership**

### **Columbia's Last Mission**

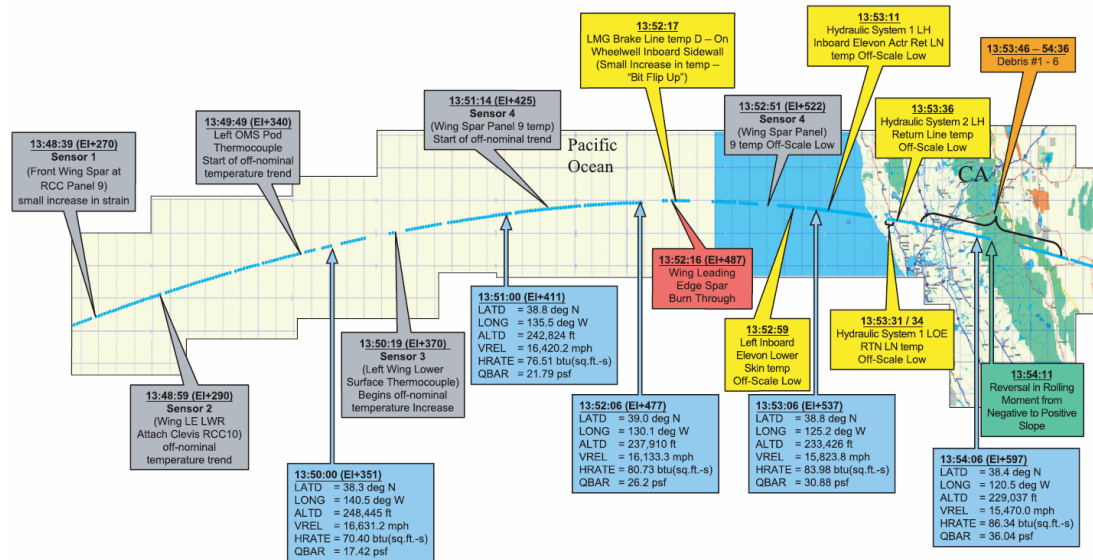
Figure 2.1. This simplified timeline shows the re-entry path of Columbia on February 1, 2003. The chart is color-coded: blue boxes contain position, attitude, and velocity information; orange boxes indicate when debris was shed from the Orbiter; green boxes are significant aerodynamic control events; gray boxes contain sensor information from the Modular Auxiliary Data System; and yellow boxes contain telemetered sensor information. The red boxes indicate other significant events.
