THE TOOTHBRUSH TOOTHBRUSH TOOTHBRUSH TOOTHBRUSH TOOTHBRUSH

Collaborative problem solving, a jumper lead, and a toothbrush turned around an unsuccessful late-August spacewalk.

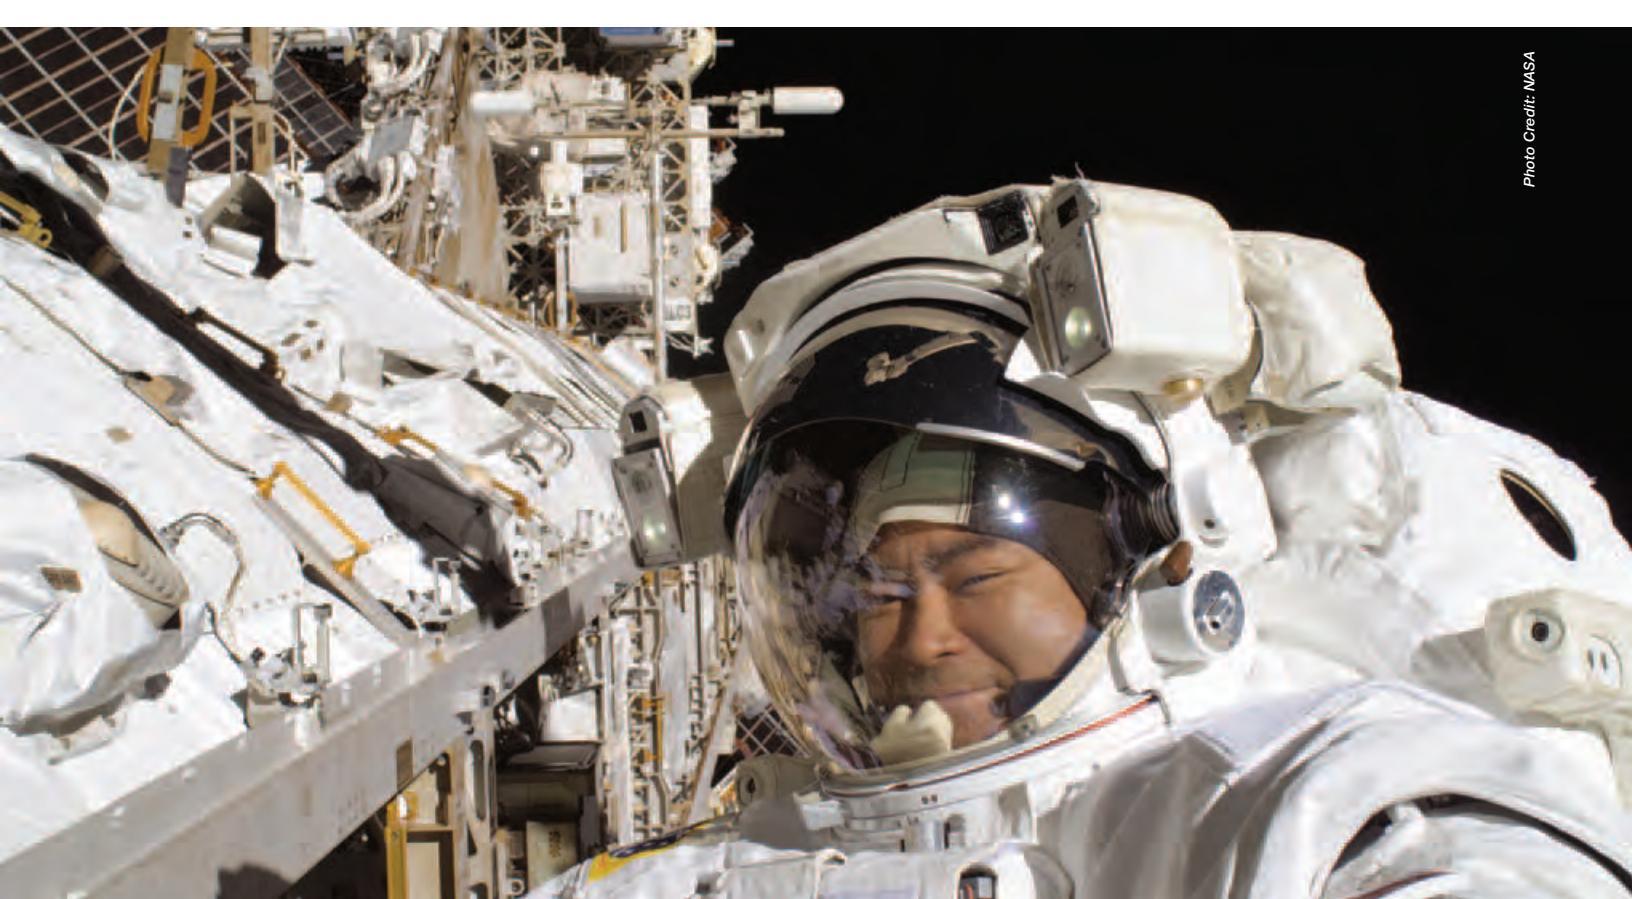
Japan Aerospace Exploration Agency Astronaut Aki Hoshide participates in a third session of extravehicular activity. During the 6-hour, 28-minute spacewalk, Hoshide and NASA Astronaut Sunita Williams (out of frame) completed the installation of a main bus switching unit that was hampered by a possible misalignment and damaged threads where a bolt must be placed. They also installed a camera on the International Space Station's robotic arm, Canadarm2.

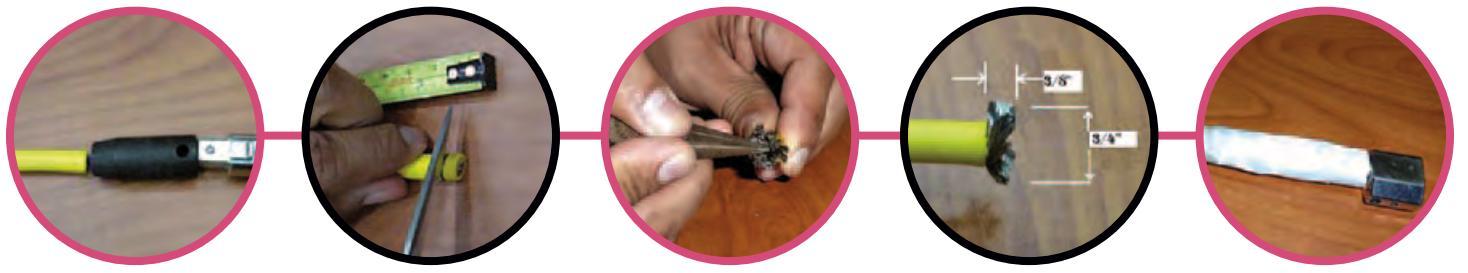
Images of the jumper cable modified to create the wire brush tool.

Badillo and another team member started making prototypes. Badillo grabbed a 4-gauge jumper lead identical to one found on ISS, removed the insulation from one end, and frayed the wires inside, creating a brush. The team liked what Badillo developed and improved upon the tool by using EVA tape to make the flimsy lead firm and finding ways to ensure the crew could grab and maneuver the tool with their oven-mitt-like gloves.
